This errata sheet provides updated information about known device issues affecting Stratix® IV GT devices.

Production Device Issues for Stratix IV GT Devices

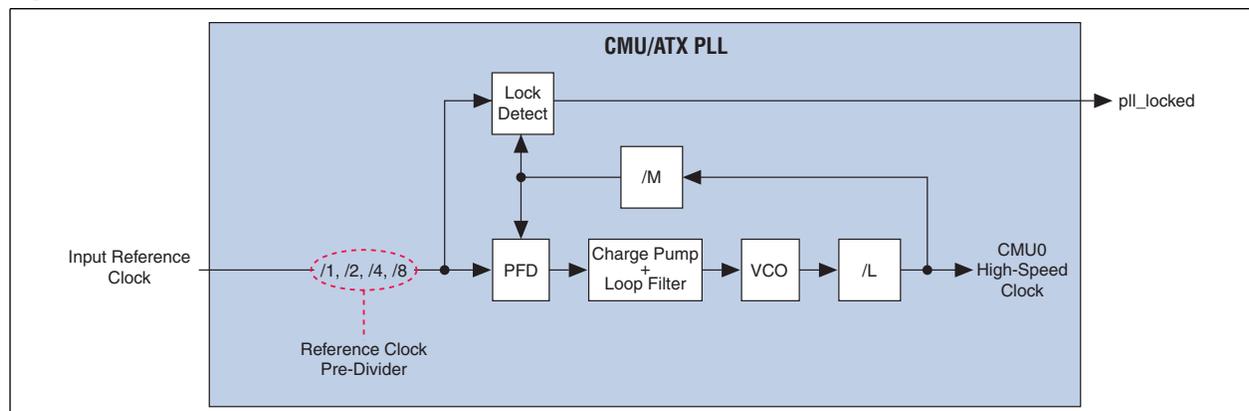
Figure 1. Reference Clock Pre-Dividers in Transmitter PLLs

The transmitter PLL lock status signal (`p11_locked`) does not deassert when the `p11_powerdown` signal is asserted in configurations that use the reference clock pre-divider of 2, 4, or 8. [Figure 1](#) shows the reference clock pre-divider inside transmitter PLLs. This transmitter PLL lock status signal issue impacts the `p11_locked` status signal in both the clock multiplier unit (CMU) PLL and the auxiliary transmit (ATX) PLL.

If the pll_locked issue impacts your design, instantiate and connect the pll_locked_soft_logic module, as shown in **Figure 3**. You must use the pll_locked_to_corelogic output from this module in the transceiver reset logic and any user logic that relies on the transmitter PLL lock status signal.

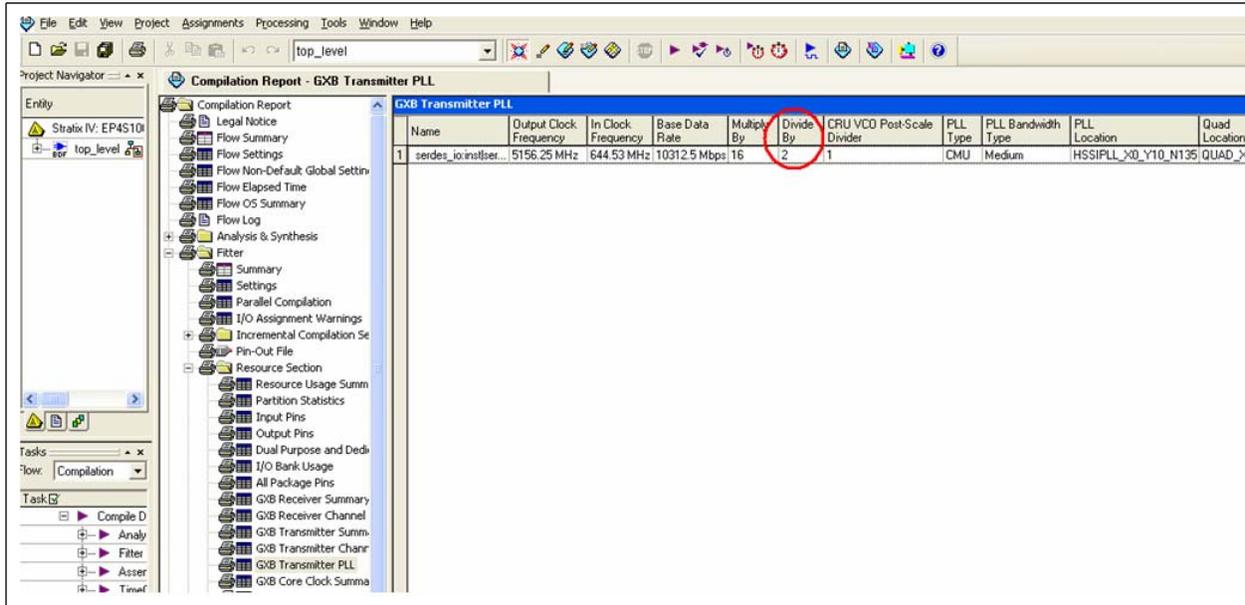
Figure 2. Determining Reference Clock Pre-Divider Value in the Compilation Report

You can determine whether the Transmitter PLL in your design uses a reference clock pre-divider of 2, 4, or 8 by referring to the Quartus II software Compilation Report. **Figure 2** shows an example of the GXB Transmitter PLL report, which you find in the “Resources Section” under “Fitter” in the Compilation Report. If the value in the **Divide By** column reads 2, 4, or 8, your design is impacted by the pll_locked status signal issue.

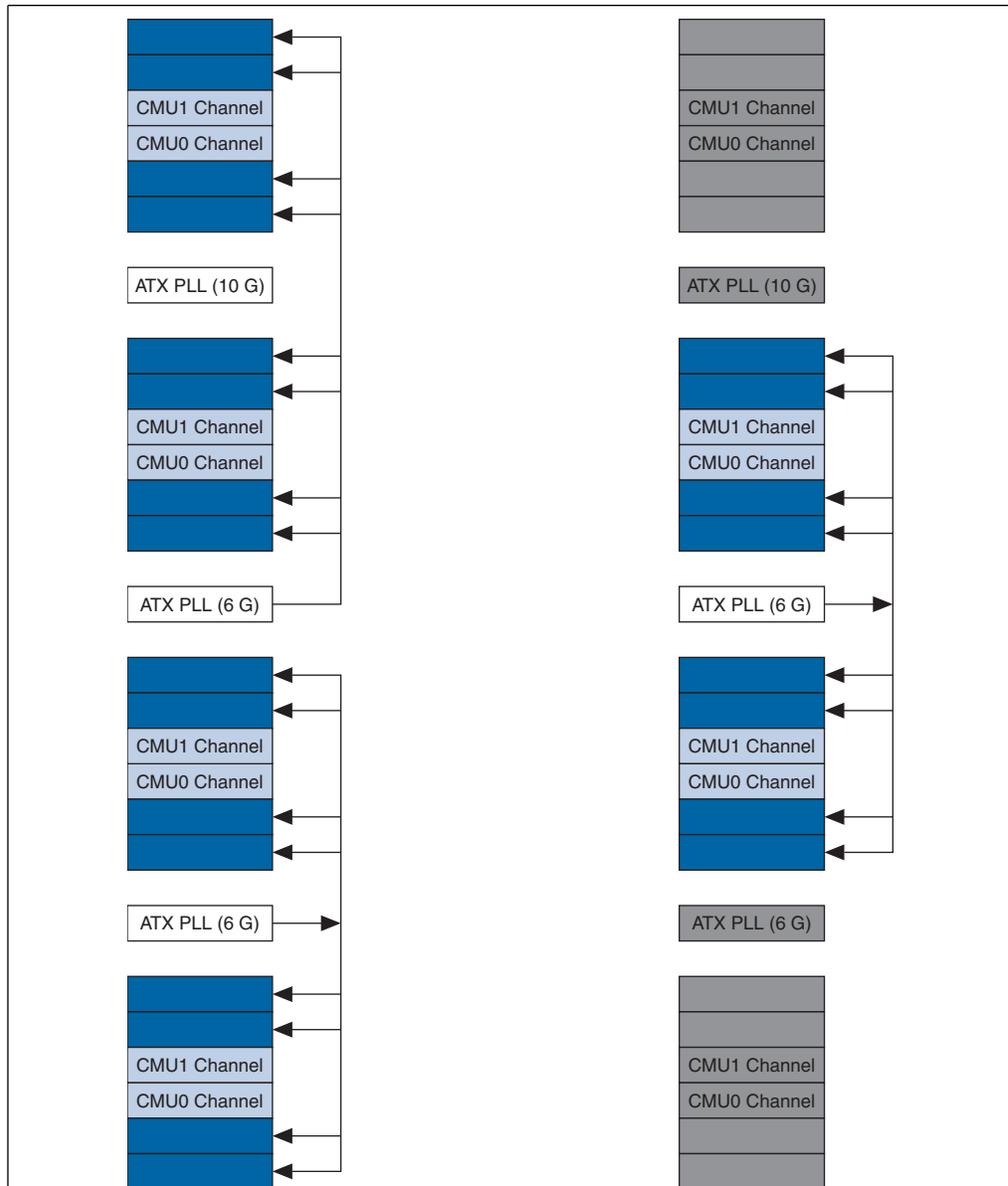
Figure 4. Placement Restrictions in Basic x8 Mode Using ATX PLLs (6G) ⁽¹⁾

(1) This figure shows different instantiations of Basic x8 with the 6G ATX PLL in an EP4S100G5F45 device. The best selection is to use the PLL between the transceiver blocks, but other configurations are possible. The data rate can be as high as 6.5 Gbps as long as the reach is no longer than two transceiver blocks in one direction. For example, the bottom ATX PLL could not drive the top two transceiver blocks at 6.5G, because the top transceiver block is three transceiver blocks away.

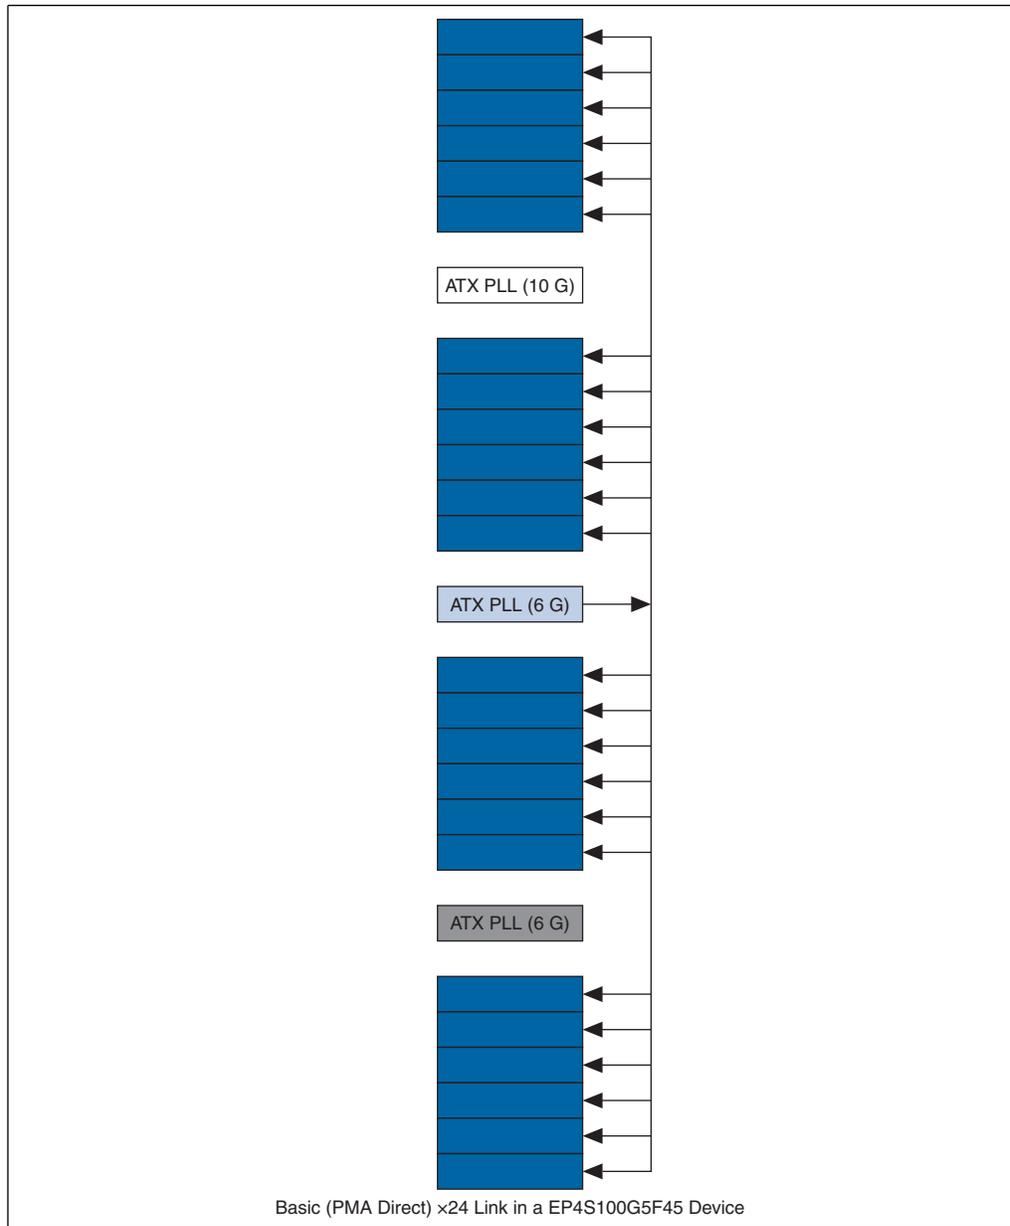
Figure 7. Placement Restrictions in Basic (PMA Direct) xN (N=24) Using ATX PLLs (6G)

ALTGX Functional Mode	TX PLL Type	Bonding	Supported Data Rates		Placement Restrictions
			Speed Grade	Max Data Rate (Gbps)	
Basic x1 and Basic x4	ATX PLL (6G)	Up to x4	All ⁽¹⁾	6.5	It is best to use the ATX PLL (6G) adjacent to the transceiver block where the channels are located. For more information, refer to Figure 5 on page 13 . The maximum distance away from the ATX PLL is two transceiver blocks.
Basic x8	CMU PLL	Up to x8	All	6.5	—
	ATX PLL (6G)	Up to x8	All ⁽¹⁾	6.5	It is best to use the ATX PLL (6G) between the two transceiver blocks. For more information, refer to Figure 4 on page 12 . The maximum distance away from the ATX PLL is two transceiver blocks.
Basic xN (PMA Direct)	CMU PLL	Up to x17	All	6.5	Bonded channels must be contiguous. You must use the CMU PLL in the middle transceiver block. For more information, refer to Figure 6 on page 14 .
		> x17	All	3.25	—
	ATX PLL (6G)	Up to x24	All ⁽¹⁾	6.5	You must use ATX L1 PLL (6G) for left-side bonding. You must use ATX R1 PLL (6G) for right-side bonding. For more information, refer to Figure 7 on page 15 .

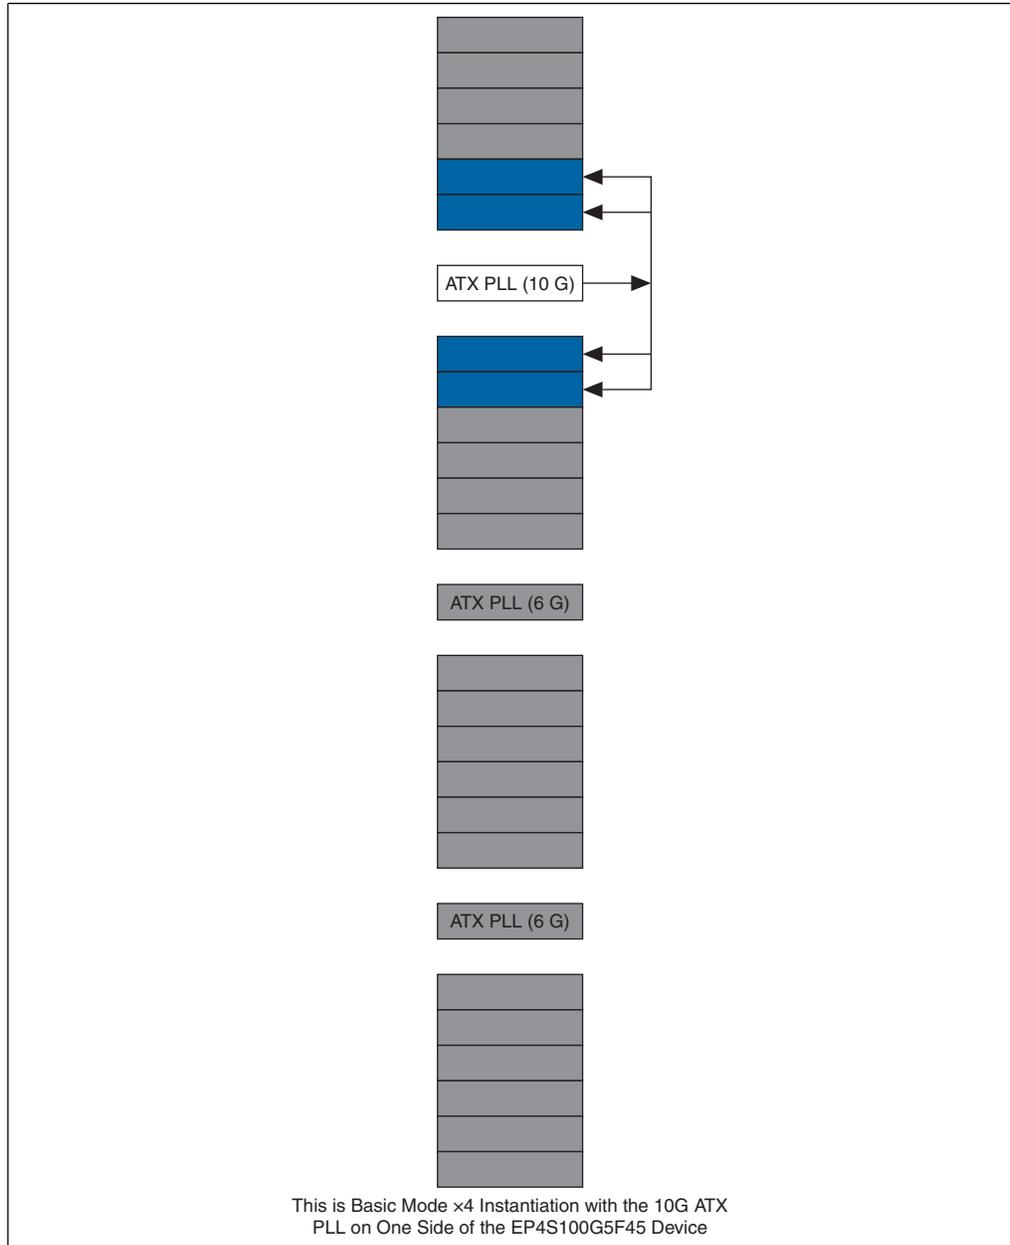
Figure 8. Placement Restrictions in Basic x1 and Basic x4 Mode Using ATX PLLs (10G)

ALTGX Functional Mode	TX PLL Type	Bonding	Supported Data Rates		Placement Restrictions
			Speed Grade	Max Data Rate (Gbps)	
Basic x1 and Basic x4	ATX PLL (10G)	Up to x4	All ⁽¹⁾	10.3	You must use the ATX PLL (10G) between the two transceiver blocks used. The ATX PLL (10G) can support the two channels just above and the two channels just below. For more information, refer to Figure 8 on page 16 .

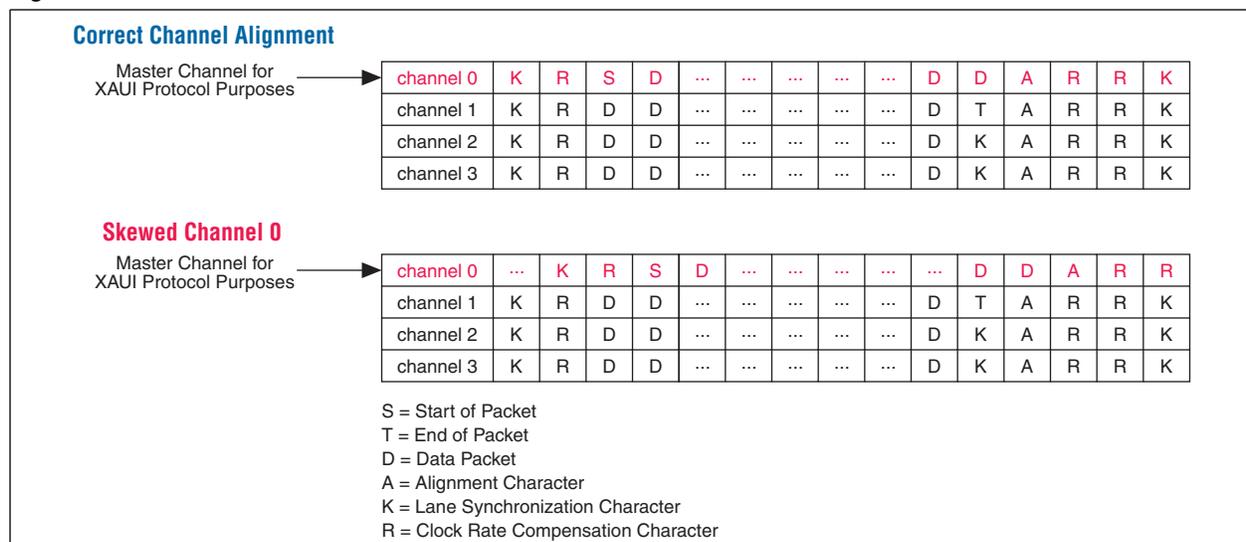
Figure 9. Rate Match FIFO Skew

In XAUI functional mode, the data out of the physical transceiver channel 0’s Rate Match FIFO may be shifted by one byte with respect to the data of the other three channels. This shifting causes incorrect idle ordered set conversion, resulting in incorrect received parallel data. The corrupted received parallel data caused by improper idle ordered set conversion or rate matcher corruption happens only during initialization or receiver channel reset (assertion of rx_analogreset or rx_digitalreset).

Figure 9 shows the channel skew.

Altera provides a soft IP solution and associated documentation, available for download at: www.altera.com/patches/xauip-softip/xauip-softip-fix-reva.zip

Integrate this soft IP into the XAUI receiver data path. Altera will fix this issue on production devices.
