PIC16F88X Family Silicon Errata and Data Sheet Clarification

The PIC16F88X family devices that you have received conform functionally to the current Device Data Sheet (DS41291G), except for the anomalies described in this document.

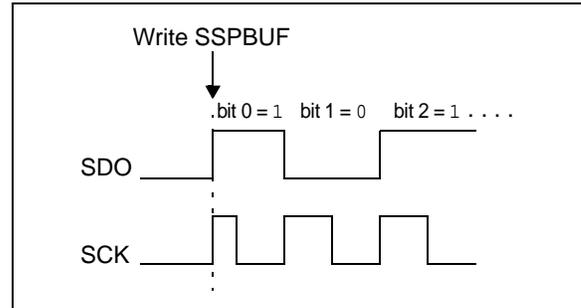
FIGURE 1: SCK PULSE VARIATION USING TIMER2/2

When the SPI is using Timer2/2 as the clock source, a shorter than expected SCK pulse may occur on the first bit of the transmitted/received data (Figure 1).

To avoid producing the short pulse, turn off Timer2 and clear the TMR2 register, load SSPBUF with the data to transmit and then turn Timer2 back on. Refer to Example 1 for sample code.

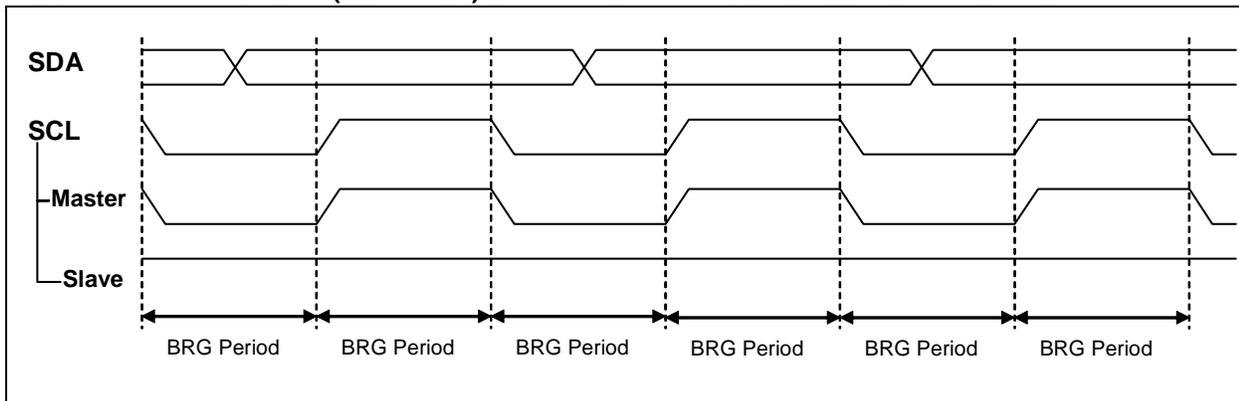
FIGURE 1: ACTUAL (CORRECT) OPERATION WITHOUT CLOCK STRETCHING

Figure 1 illustrates an expected I²C transmission in which the SCL line is completely controlled by the master device and the slave device does not attempt to stretch the clock period.

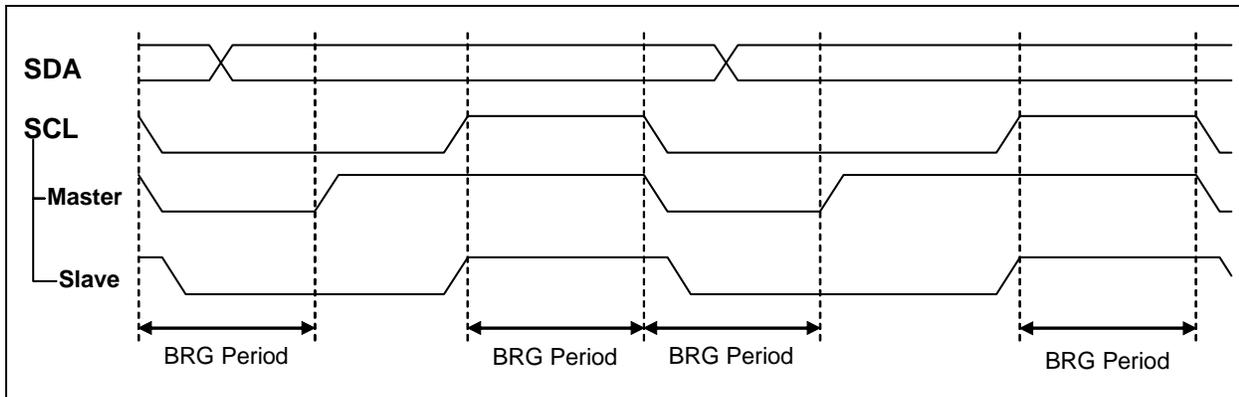
FIGURE 2: EXPECTED OPERATION WITH CLOCK STRETCHING

Figure 2 illustrates the expected operation of an I²C transmission in which the slave device has stretched the clock period by holding the SCL line low. The high time of the SCL pulse is constant, regardless of the duration of the clock stretch.

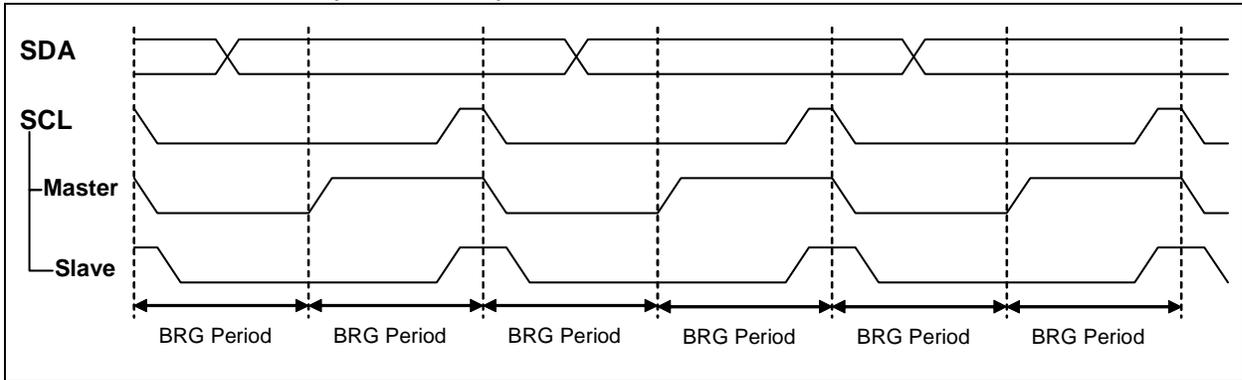
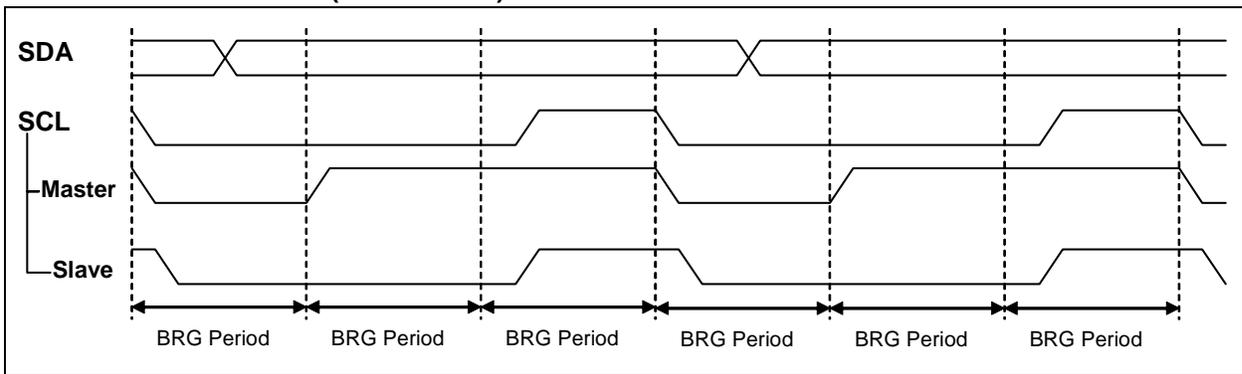
The current implementation does not ensure accurate SCL high time. During clock stretch, the MSSP device will erroneously continue running the BRG counter. At the end of the clock stretch, the BRG counter continues to count down for the

remainder of the BRG period, and then the MSSP device will immediately resume transmitting the data.

Figure 3 and Figure 4 illustrate an actual I²C transmission in which the slave has stretched the clock period by holding the SCL line low. Note that the high time of the SCL signal has shortened from the expected time.

Set the communication speed to match the slowest device on the bus. This ensures that no slave device will perform clock stretching.

It is possible to dynamically adjust the communication speed to match the device being addressed by modifying the BRG register. However, the behavior of slower slave devices must be understood and speed adjustments made such that no slave performs clock stretching.
