ENC424J600/624J600

ENC424J600/624J600 Silicon Errata and Data Sheet Clarification

The ENC424J600/624J600 devices that you have received conform functionally to the current Device Data Sheet (DS39935B), except for the anomalies described in this document.

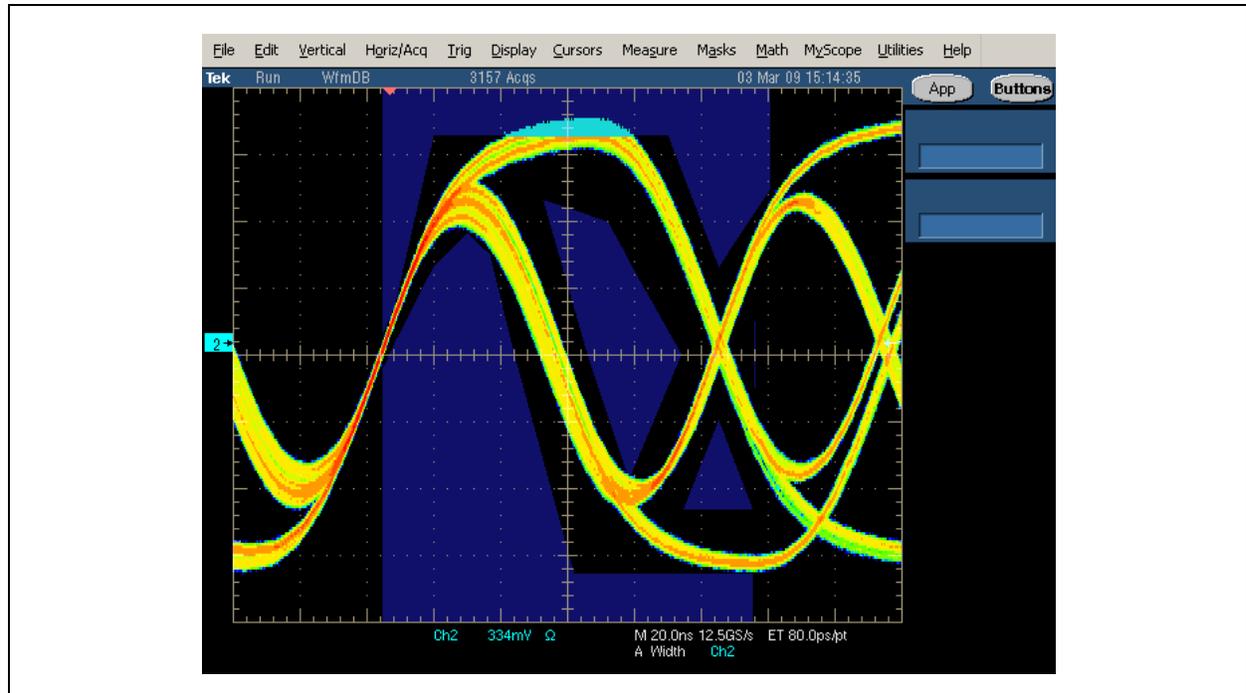
FIGURE 1: 10Base-T MAU EYE DIAGRAM

When transmitting random data in 10Base-T mode, the PHY transmit waveform slightly violates the MAU eye diagram keep-out zones specified in the IEEE 802.3™ Std. 2005, Section 14.3.1.2.1. Specifically, the waveform amplitude is slightly too high for '0' to '1' and '1' to '0' bit transitions when tested against the twisted-pair model, as shown in Figure 1.

This issue applies only to 10 Mbps speed and is unlikely to cause compatibility problems in real networks. When terminated with a 100Ω resistor without the twisted-pair model, the transmit waveform stays within the amplitude limits of +2.2V to +2.8V and -2.2V to -2.8V required by the standard.

None.
