Chip Errata for the i.MX28

This document details all known silicon errata for the i.MX28. [Table 1](#) provides a revision history for this document.

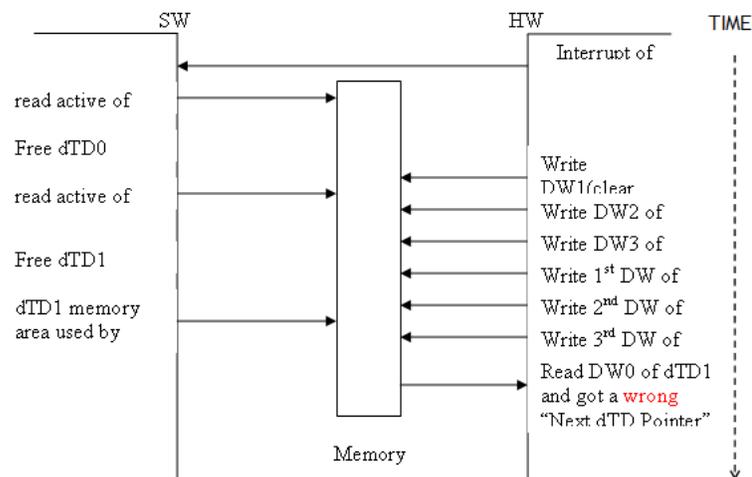
Figure 1. dTD Issue Sequence of Events

USB controller may access a wrong address for the dTD (endpoint transfer descriptor) and then hangs

After step 1, if software finds the Active bit is cleared, then the dTD memory space is freed and may be allocated for another thread's use. In step 3, hardware may get a wrong dTD.

This issue only occurs in USB INCR8 mode, because steps 1 and 2 have 6 SINGLE AHB transfers in INC8 mode, but only two burst AHB transfers in INCR mode.

This issue only occurs when the dTD list is used; because if only one dTD is used, the software only checks the Active bit after an interrupt is received (step 3). However, when the dTD list is used, the software may check the entire list after the interrupt for the first dTD is received, when the hardware has just finished the transfer of the second dTD.

Figure 1 illustrates this issue.

USB Controller may hang if dTD is freed too quickly.

Postpone freeing the current dTD; free it when its next dTD can be freed, so the last completed dTD (followed by an ACTIVE dTD) is always freed when the next IOC irq comes.
